Navajo Abandoned Uranium Mine

Site Screen Report

Charles Huskon No. 10 AUM Site

Navajo AUM Western Region

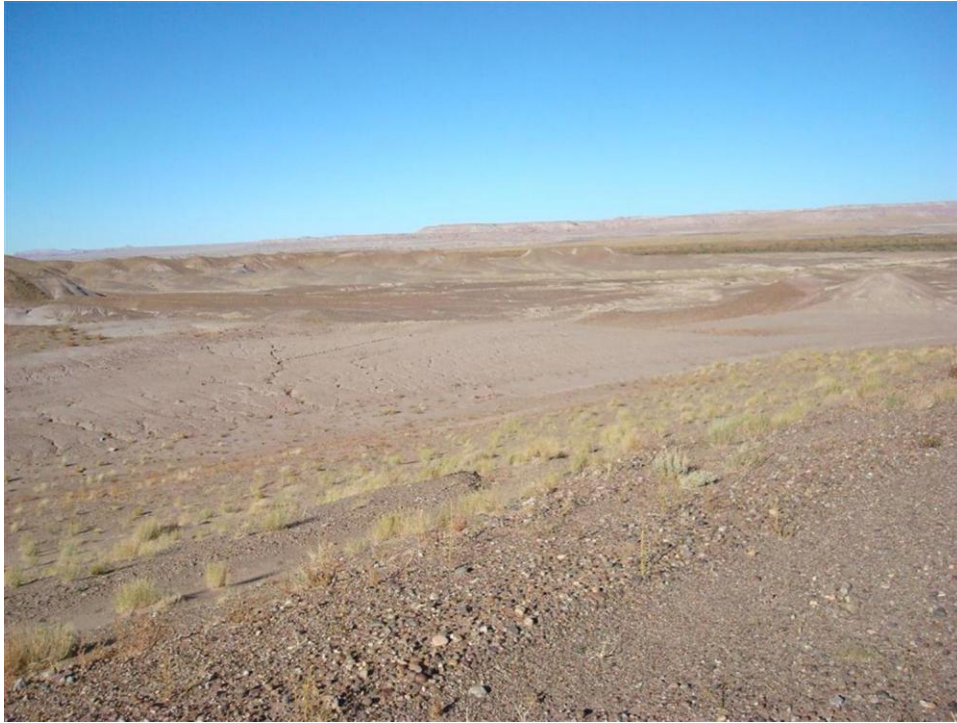
Reclamation cap in center of site

Photo 1. Charles Huskon No. 10, Site #141, reclamation area

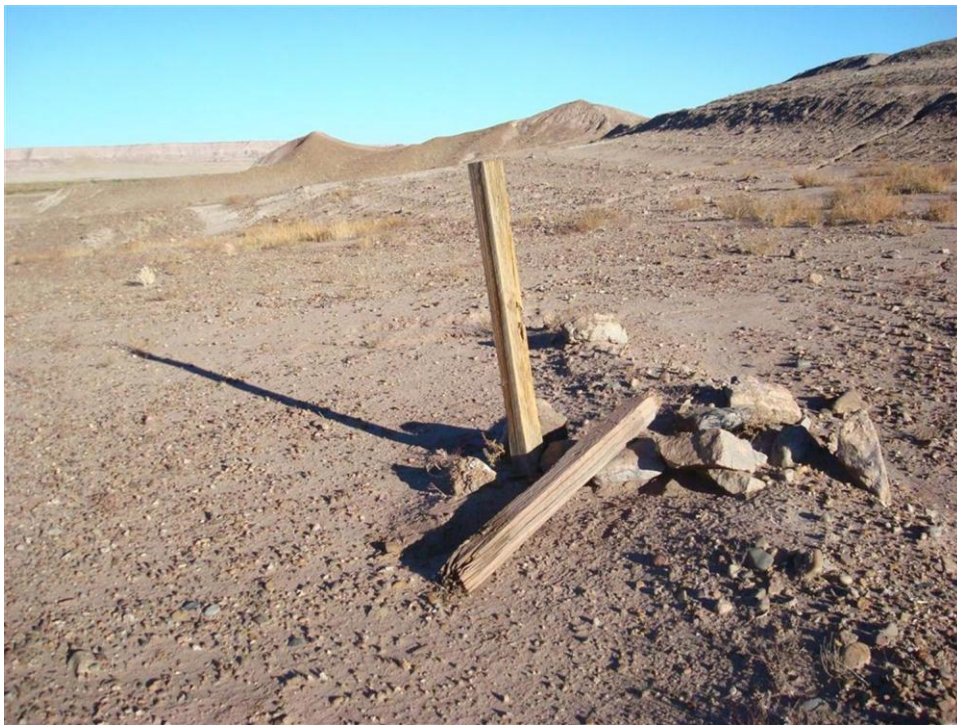
Photo 2. Charles Huskon No. 10, Site #141, wood debris

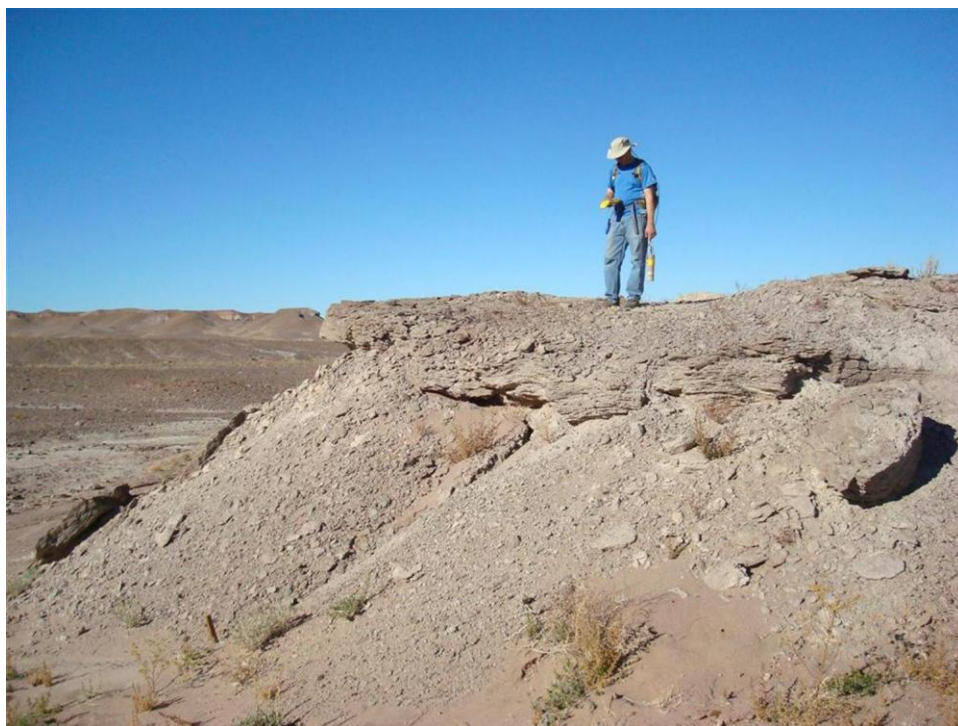
Photo 3. Charles Huskon No. 10, Site #232, elevated readings
